Steep Cut Slope Composting: Field Trials and Evaluation

Draft Plot Construction Report

Montana Department of Transportation
P.O. Box 201001
Helena, MT 59620-1001

January 6, 2009

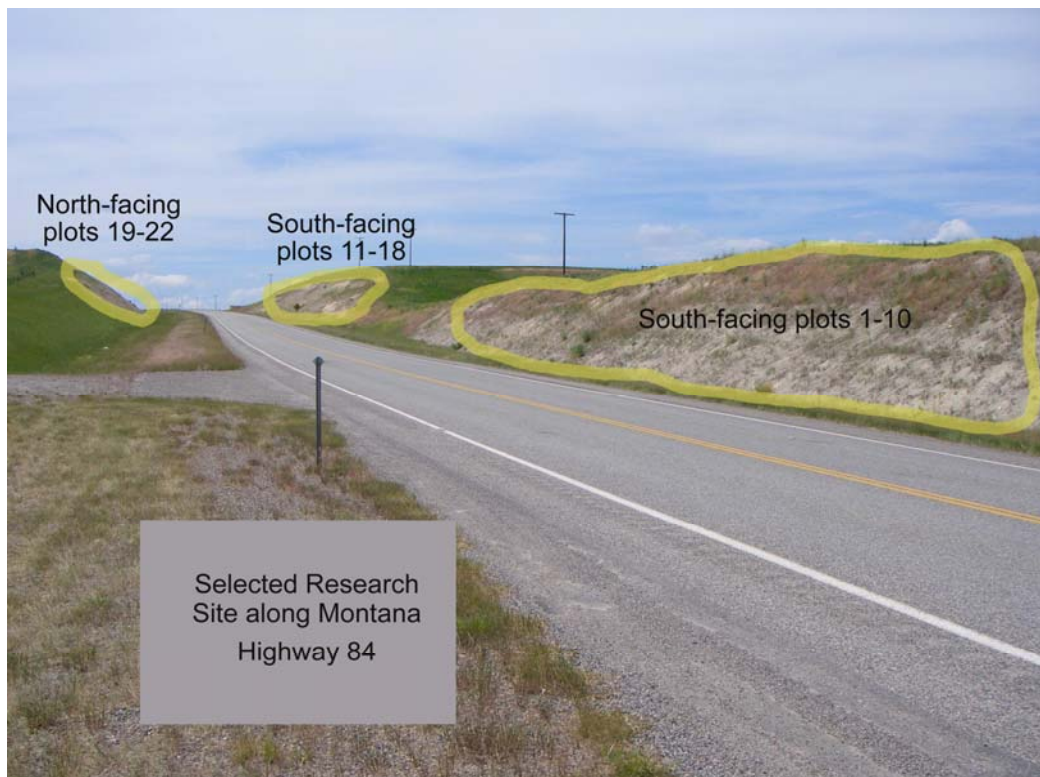
Figure 1. Roadside overview of research site location along Montana Highway 84

A test site was located approximately 25 kilometers (15 miles) west of Bozeman on Montana Highway 84 (see Figure 1). This lane widening road project was completed in 2002. Steep slopes were cut into tertiary-age sedimentary parent material. Slopes did not receive a topsoil application before seeding during post-construction reclamation. In 2008 these slopes were nearly devoid of vegetation; approximately 1-5 % of the test site had vegetative cover.

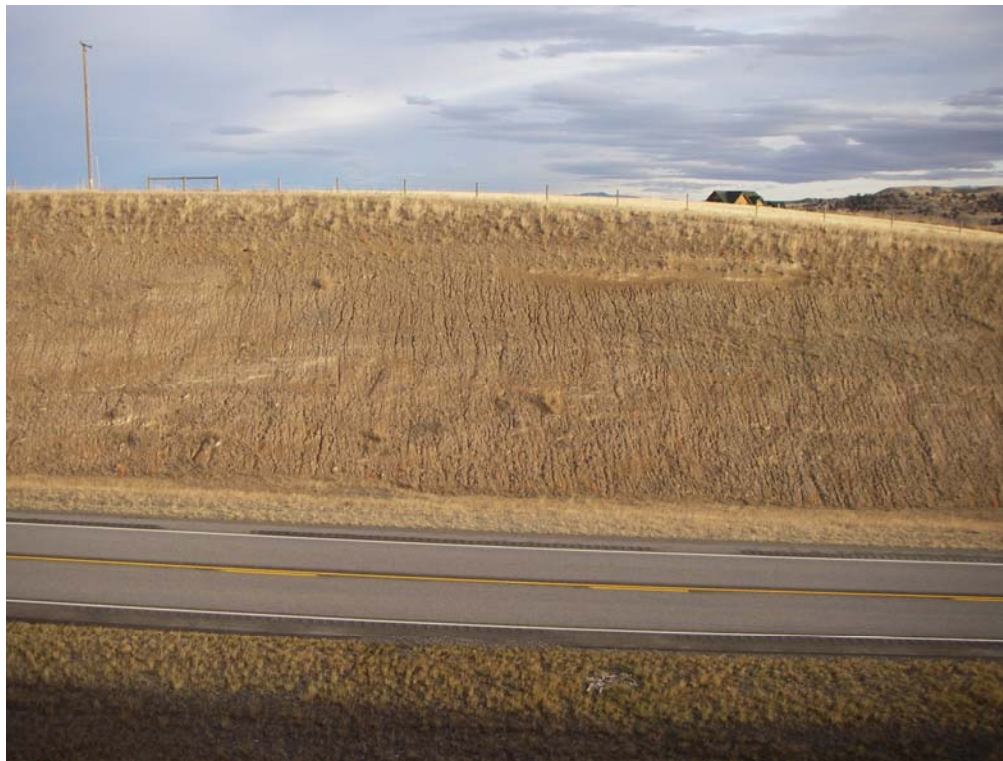
Figure 6: Evidence of sparse vegetation on slopes before test plot construction.

This lane widening road project was completed in 2002. By the autumn of 2008 these slopes remained nearly devoid of vegetation. However, some sparse vegetation was evident on the test site (Figure 6). The MDT Reclamation Specialist conducted an ocular sampling to characterize the vegetation on the site on 4 November 2008. At this time of year, all vegetation was senescent at the time of seed bed preparation. Vegetation cover was less than 5% and comprised principally of weedy species and remnants of the seed mix used after construction of the road widening project in 2002. The dominant desirable species observed was slender wheatgrass, *Elymus trachycaulus*. These plants were widely spaced and comprised less than 1% cover. The dominant invasive species observed was cheatgrass, *Bromus tectorum*, and several spotted knapweed, *Centaurea maculosa*. Trace amounts of other species were observed, yet insufficient plant cover was present to control erosion and provide soil stabilization.

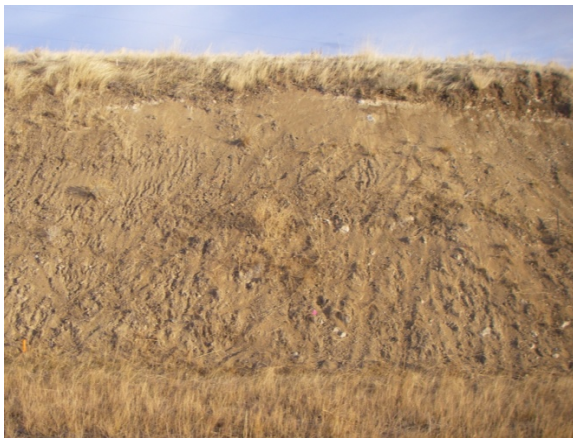
Plot 10 Before Construction

Plot 10 After Construction

Rolls of the erosion control fabric were placed on top of the compost in overlapping applications and stapled/staked to the soil surface on test plots 10 and 18. The uppermost edge of the fabric was staked and buried in an anchor-trench.

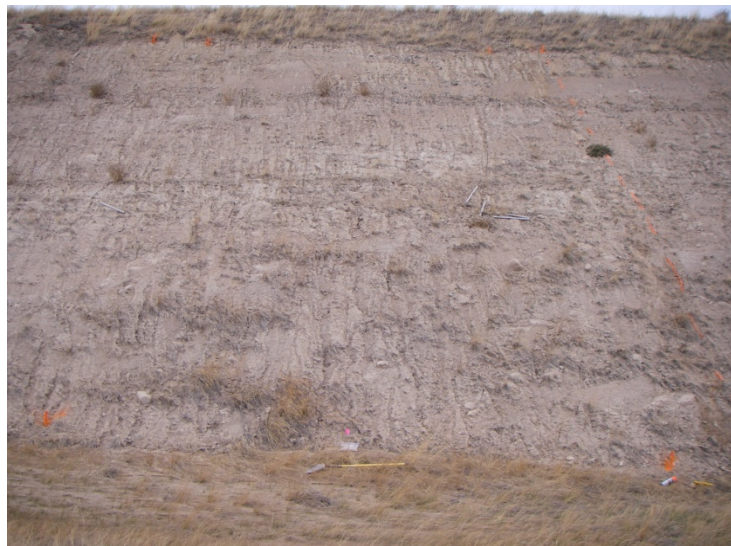
Plot 12 Before Construction

Plot 12 After Construction

The two test plots that received the netting treatment, plot numbers 12 and 14, were prepared by removing the aerial portion of all existing vegetation to facilitate the spreading and attachment of the netting over the compost blanket. These two test plots were cleared of vegetation by treating with a gas powered weed trimmer. The remaining 20 test plots did not receive any pre-seeding preparation except for the removal of the occasional noxious weed, primarily spotted knapweed. Cheatgrass was also present across the test site but these small ubiquitous exotic plants were not removed. Young cheatgrass plants have apparently germinated and established on several of the plots and adjacent land as indicated by 1-3 cm tall stems.

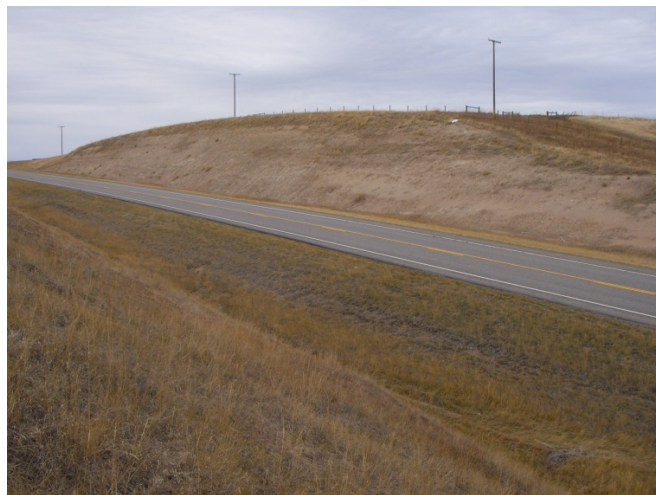
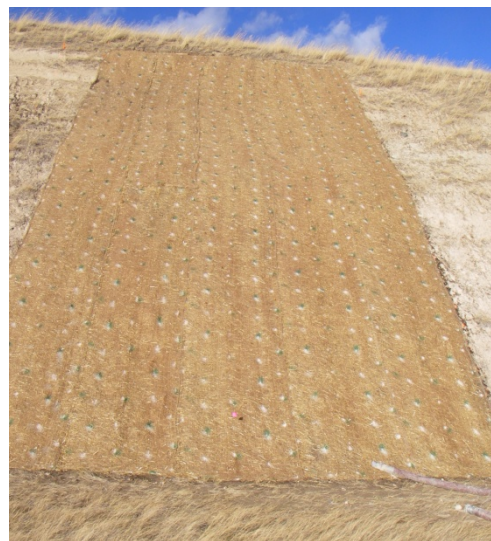
Plot 18 Before Construction

Plot 18 After Construction

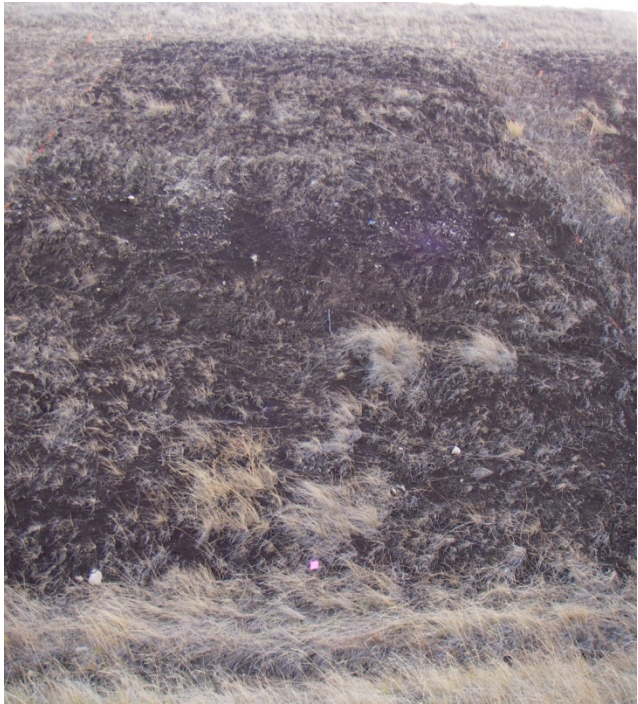
A photograph of a dirt cut slope. Two adjacent parallelogram-shaped areas are outlined in blue. The left one is labeled "19" and the right one is labeled "PLOT 20". The slope is similar to Plot 19 before construction.

A photograph of the same slope as Plot 20 before construction, but now covered with a dense layer of dark brown, fibrous compost material. The surface is uneven and textured.
<p>Plot 20 Before Construction</p>	<p>Plot 20 After Construction</p>
